Sediment Impact Assessments for the Rio Guanajibo at Mayaguez and San German, Puerto Rico

by William A. Thomas

Final report

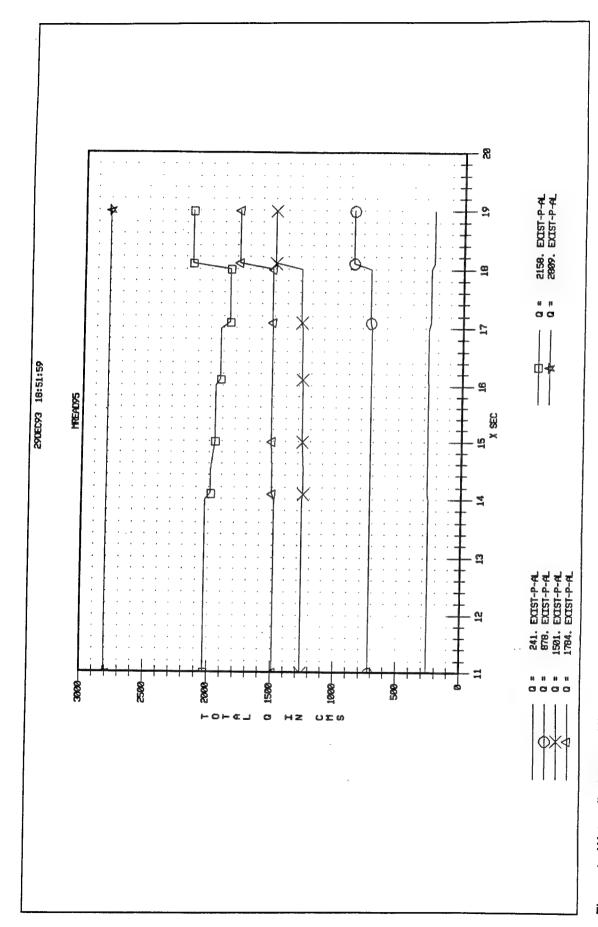
Figure 4. Water discharges, HEC2 model of existing channel, San German Project Reach

The basis for these average hydraulic parameters is shown in Figures 4 through 11. Figure 4 shows how the water discharge varies within the HEC2 data set. These water discharges are plotted versus cross section numbers from

the HEC2 geometry, and in this case they span the entire HEC2 model. The project reach begins at "X SEC 15.1" on the abscissa and extends up to cross section number 13.

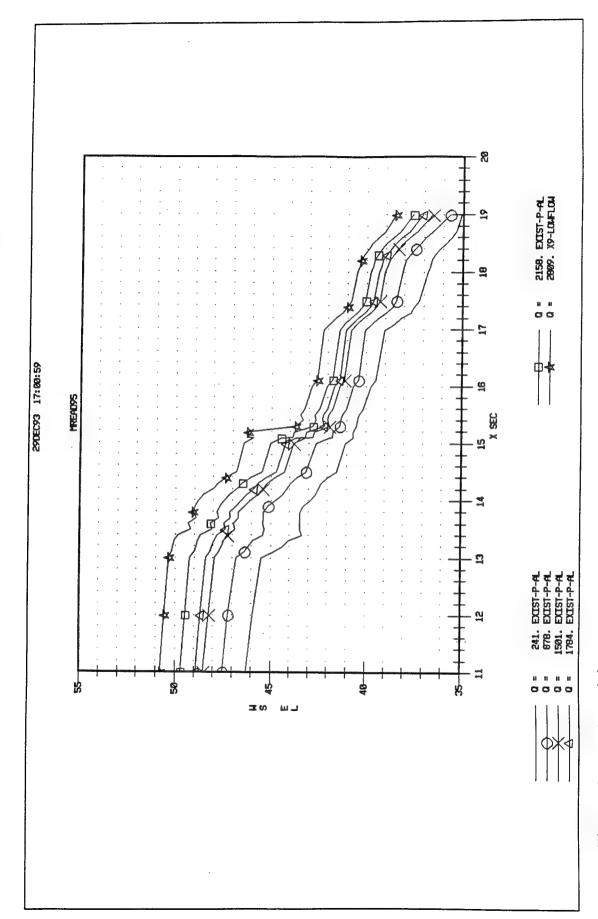
Figure 5. Water surface profiles, existing conditions, San German Project Reach

Figure 5 is the HEC2 water surface profiles for these discharges. Notice the legend keys on water discharge. In this case, it is the same as Figure 4. In the general case, the water discharge at the downstream end of the averaging reach is used in the legend to reference the plot. Figure 4 profiles provide that water discharge at each cross section. It can be used to define the legend for profiles through any portion of this Tape95 data set. Figure 5 shows calculated water surface profiles for these flows.

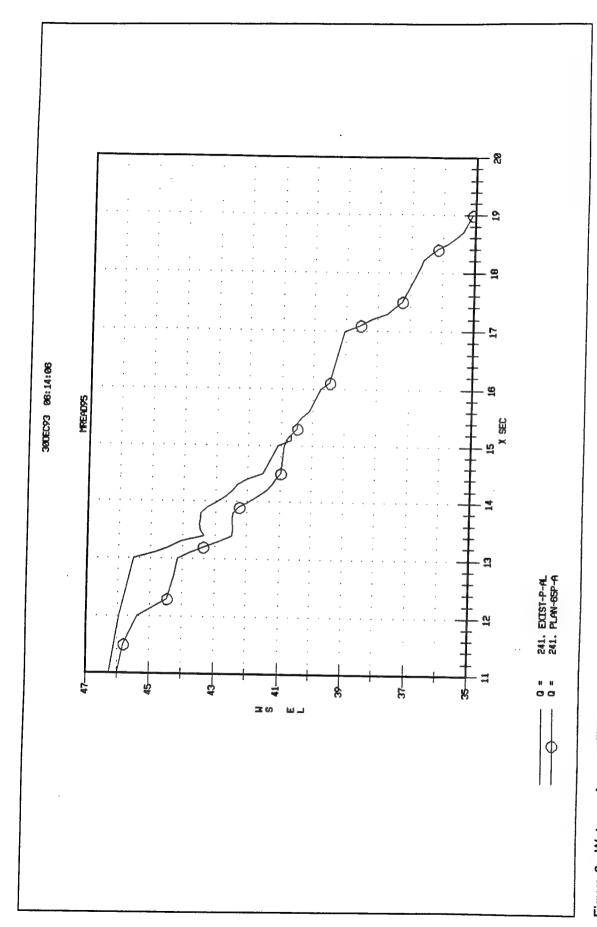
Figure 6. Water surface profiles, existing and project conditions, 2-yr flood peak, San German Project Reach

Figure 6 is the HEC2 water surface profile for the 2-yr flood for existing and project conditions. It shows the slope change in the project reach as well as the convergence of profiles upstream from the project reach. The channel over which the profiles return to preproject conditions is referred to as the "approach channel" in ER 1110-2-1405. That convergence is not yet complete in Figure 6 which indicates some additional design work is needed on the approach channel.

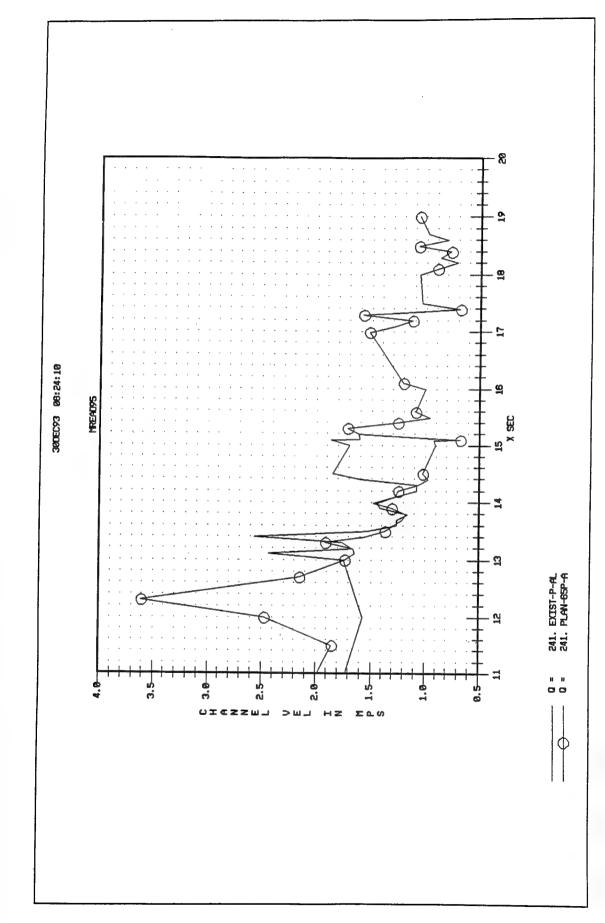
Figure 7. Channel velocities, 2-yr flood peak, San German Project Reach

Figure 7 shows the channel velocities. They fluctuate through the project reach, but there is no trend in the existing channel. The average value will be used to test channel stability.

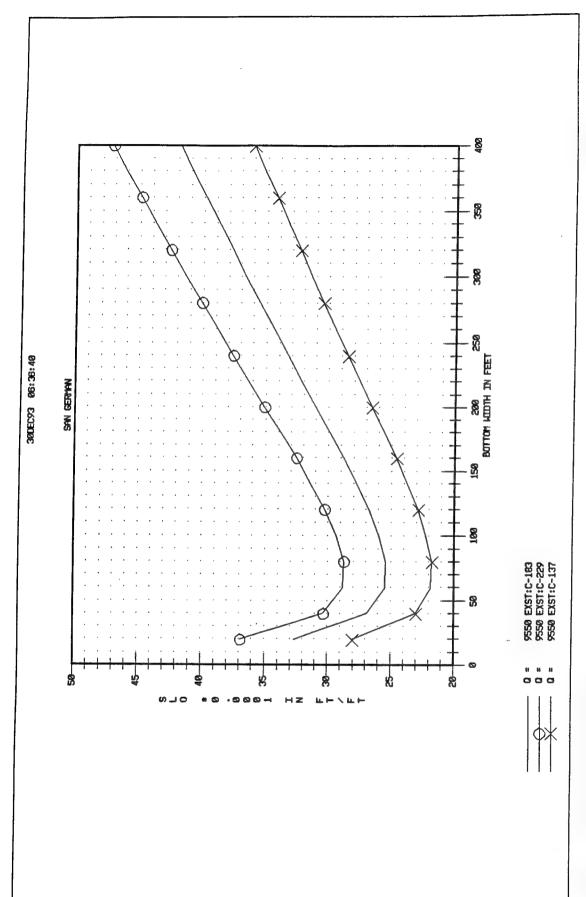
Figure 12. Calculated channel width and slope for existing conditions, stable channel analytical method, San German Project Reach

Channel Stability Based on the Analytical Method. Figure 12 shows the calculated width-slope relationship from existing channel conditions. (Note: This calculation is available only in English units.) The inflowing sediment concentration, i.e. the bed material load entering the project reach, was calculated from a supply reach. For that calculation, the channel hydraulic properties from Table 2 were used to develop one representative trapezoid. The top width of that trapezoid is 220 feet (67.04 m) and the depth is 8 feet (2.51 m). The channel was given side slopes of 1V:2H which resulted in a bottom width of 190 feet (57.91 m). The effective bank roughness was assigned a value of 4 feet and Manning's n-value for the bank was calculated, by Strickler's Equation, to be 0.043. The Brownlie bed roughness predictor was used to calculate the bed n-value.

The sediment size in this stream, 13 mm, is considerably larger than the 2 mm maximum size recommended for the Brownlie Equation. At this point in time, however, there is no alternative to Brownlie.

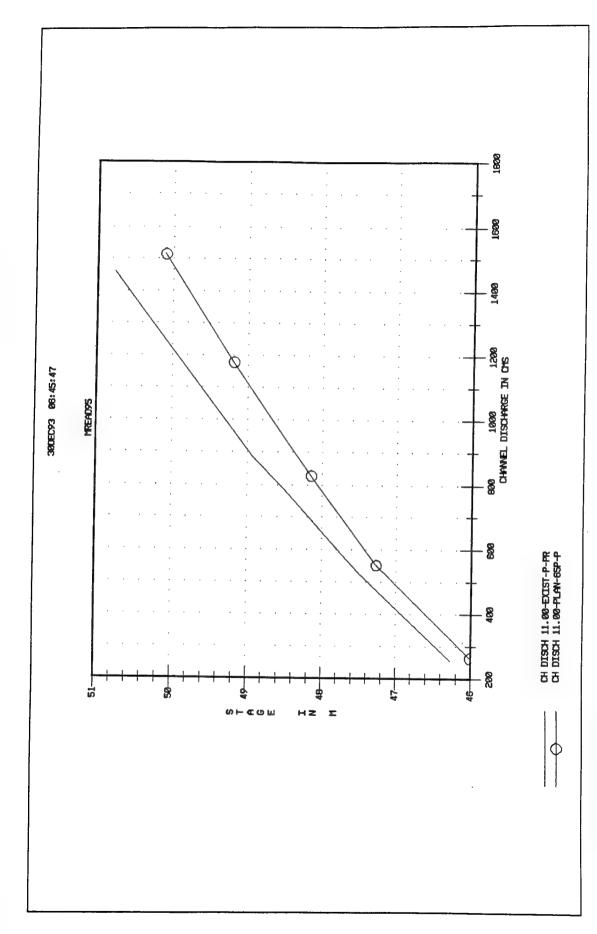
Figure 15. Calculated stage-discharge relationship, approach channel, San German Project Reach

The approach channel is that reach of river upstream from the project reach over which the energy gradient returns to preproject conditions. Figure 15 shows the calculated stage-discharge rating curve at cross section 13. The with-project stage is from 0.3 to 0.8 m lower than preproject conditions which indicates the approach channel should extend further upstream. Figure 16 is another way to view the project impact on the energy gradient. It shows project velocities to be as much as 0.5 m/s faster than preproject velocities were at this section. In the design phase more attention needs to be given to the approach reach.

The calculated stage-discharge rating curve at cross section 13 is from 0.3 to 0.8 m lower than preproject conditions which indicates some additional work is needed to design the approach channel. That is a detail which can be handled in the next phase of project development. Some maintenance in the exit channel is likely immediately after the project goes into operation, but the reach of river which is the exit channel to this project is expected to function as it did historically.
